Press Release PI 182

Supfina Improves Corrosion Protection

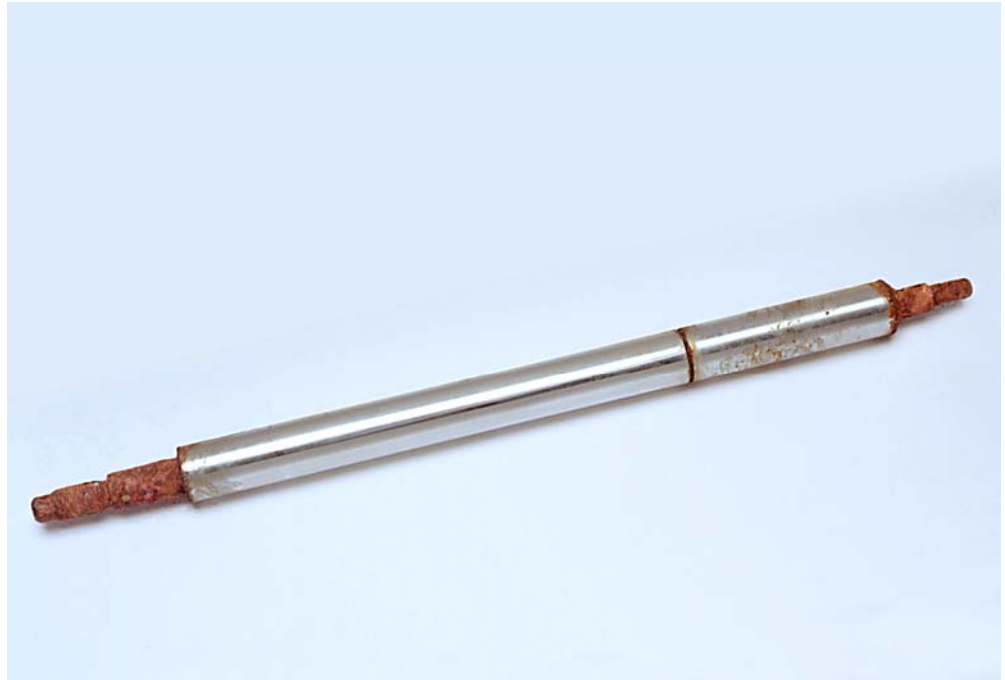
Even chromed parts exhibit traces of corrosion when exposed to a salt spray test. The surface imperfections i.e., rust spots, often lead to functional problems and shorten the life span of the affected parts. The Superfinishing process from Supfina makes it possible to notably reduce corrosion build-up. The pictured piston rod above was ground throughout the length after being chromed and after that it was finished using the Supfina Superfinishing process on the left half only. After the salt spray test the “better half” is easily recognizable. Along with the corrosion protection, the Supfina process also provides dramatically better sealing characteristics, decreased wear and a lower friction coefficient of the superfinished part.
